**DEPARTMENT OF TRANSPORTATION**

Contract #: 04-0120F4Cty: SF/ALA Rte: 80 PM: 13.2/13.9File #: 69.28**WELDING INSPECTION REPORT****Resident Engineer:** Pursell, Gary**Address:** 333 Burma Road**City:** Oakland, CA 94607**Report No:** WIR-006499**Date Inspected:** 01-May-2009**Project Name:** SAS Superstructure**OSM Arrival Time:** 645**Prime Contractor:** American Bridge/Fluor Enterprises, a JV**OSM Departure Time:** 1845**Contractor:** Zhenhua Port Machinery Company, Ltd (ZPMC), Changxing Island **Location:** Shanghai, China

## WELDING INSPECTION REPORT

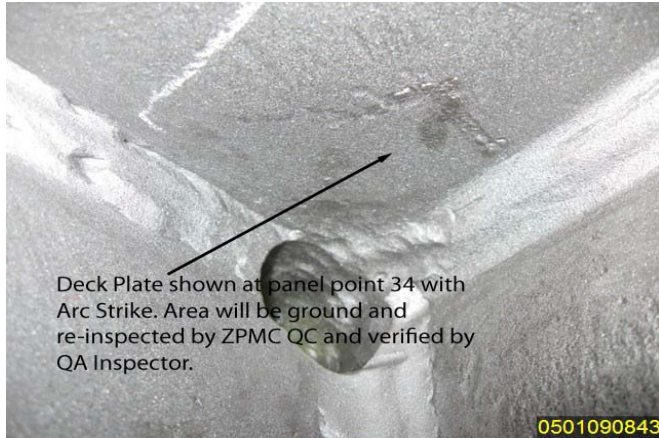
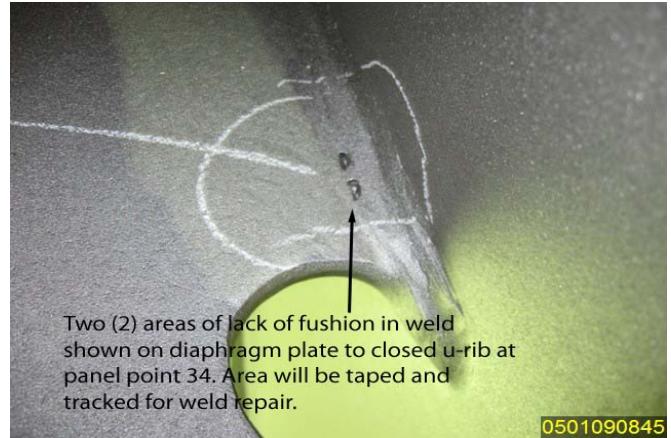
Segment 5BW: QA Inspector received notification that segment 5BW interior top has been blast cleaned and the welds and base material have been visually inspected by ABF and ZPMC QC personnel and is ready for QA visual inspection verification. QA Inspector performed visual verification on QC inspectors accepted welds and base material on the interior top of the segment. QA Inspector marked Thirty Four (34) indications (arc strikes, unacceptable weld profile, base material mishandling, rollover, and weld spatter) that are unacceptable to AWS D1. 5 (02) section 6.26. QA Inspector informed ABF QC and ZPMC QC personnel of the indications marked. ABF QC and ZPMC QC concurred with QA Inspectors findings and marked indication areas for repair. ZPMC QC directed workers to repair the marked indications by grinding. QA Inspector marked Seven (7) indications for weld repair. Indications are lack of fusion located at welds on deck plate diaphragm plates to deck plate and closed u-ribs at panel point 34 looking towards panel point 35. The areas marked for weld repair are taped and will be corrected after painting when segment is moved to segment splicing area. Specific locations of areas requiring weld repair are tracked on segment tracking spread sheet. ABF QC and ZPMC QC will reinspect the areas repaired by grinding then inform QA Inspector when inspection is complete. Representative pictures of indications shown below.
